Airtightness Testing Report

Unit 1 Wellington Lane
Bristol, BS6 5PY

P3382-02

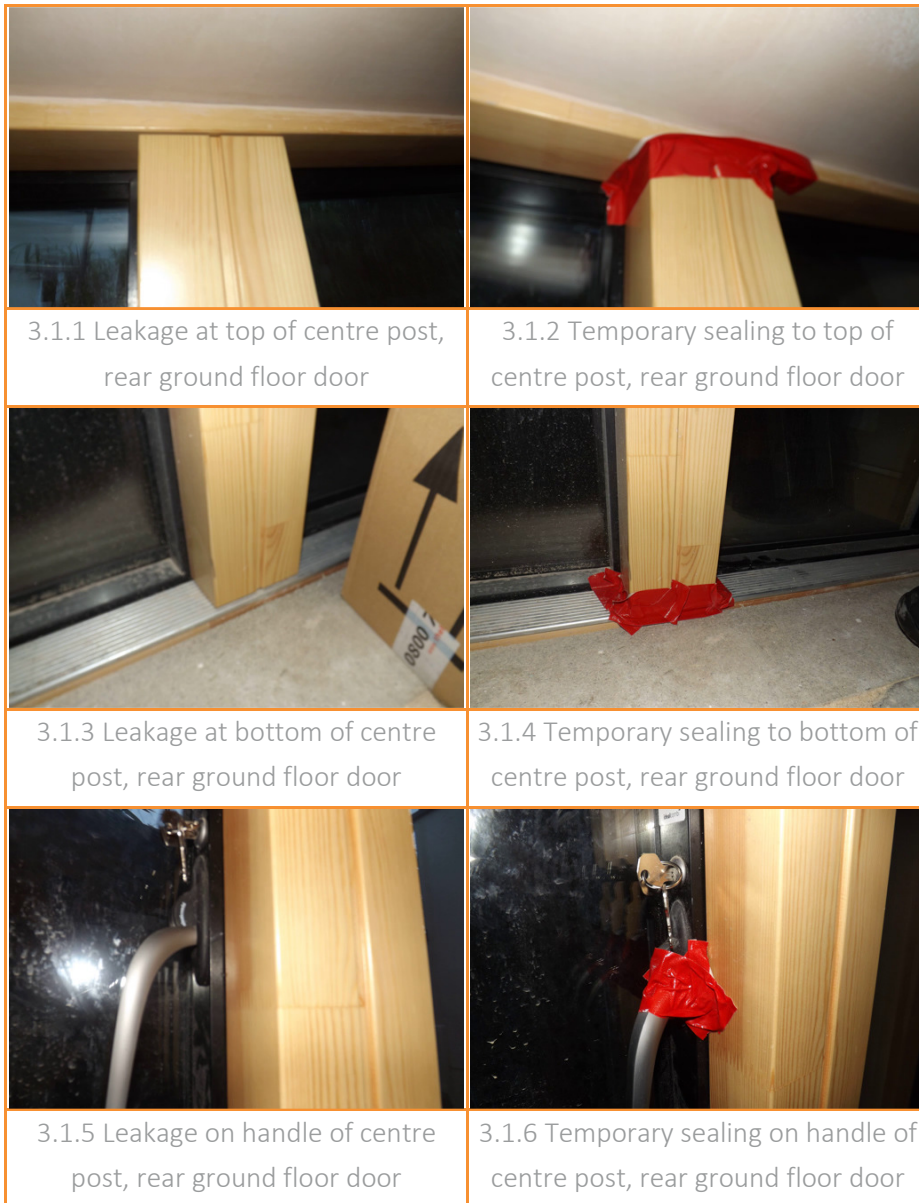
Substantial leakage was identified occurring on the two rear ground floor doors, particularly at the top and bottom of the centre posts and also on the handles.

Comparative airtightness testing was carried out after minimising the leakage associated with the two pairs of rear doors on the ground floor by temporary sealing at three locations, as shown above. These were (a) the top of the centre columns, (b) the bottom of the centre columns and (c) the door handles. This made a measurable difference in a comparative pair of depressurisation tests, undertaken at approximately 50 Pa, with an air change rate with the temporary sealing in place of 0.64 AC/hr @ 50 Pa.

This is an unsatisfactory result as the house fails to meet the newbuild Passivhaus airtightness target, although by a very small margin. The key area of air leakage appears to be:

- Associated with the centre pillars of the two rear doors on the ground floor;

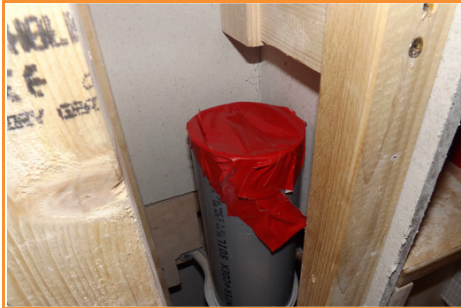
3.2.1 End of waste temporarily sealed after DIRGO removed

Considerable leakage was identified around a DIRGO in one of the downstairs bathrooms, which was poorly fitted, possibly due to the very limited space available within the timber framing of the boxing. This was removed and the end of the waste pipe temporarily sealed for the duration of testing. The installation of this DIRGO needs to be improved to achieve a satisfactory level of airtightness in the final house.

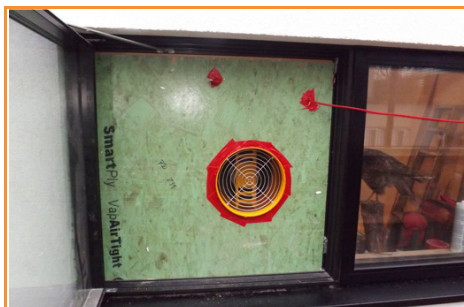
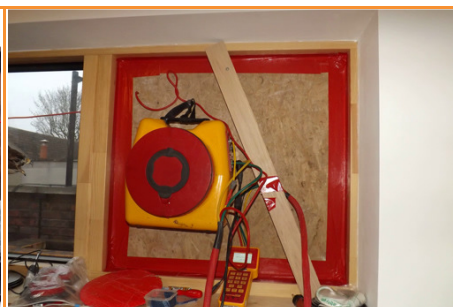
<p>A1.1) External view of test equipment mounted in window board fitted in open window off lounge on first floor</p>	<p>A1.2) Internal view of test equipment mounted in window board fitted in open window off lounge on first floor</p>

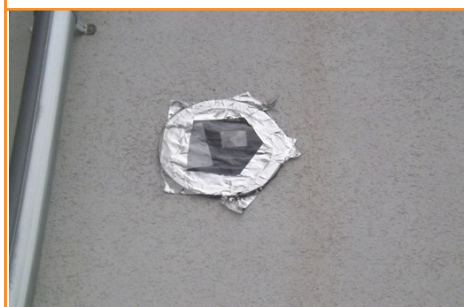
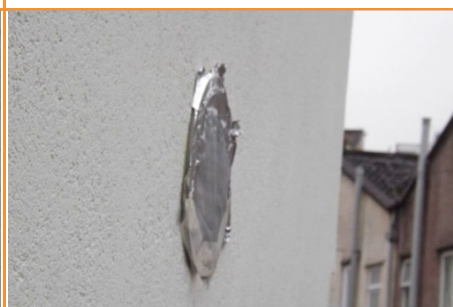
<p>A1.3) Temporary seal to external terminal of MVHR duct through rear side wall</p>	<p>A1.4) Temporary seal to external terminal of MVHR duct through rear wall</p>

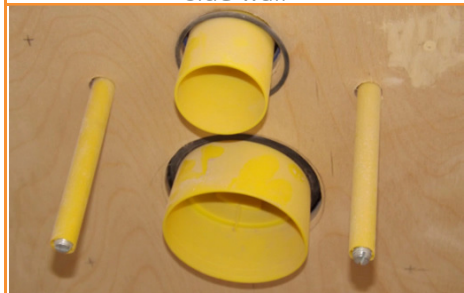
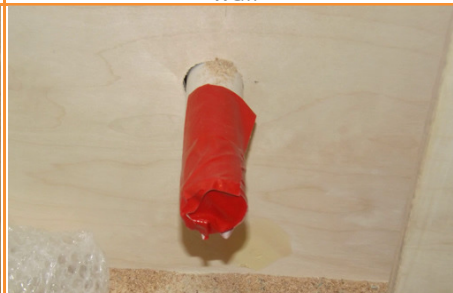
<p>A1.5) Temporary seal to toilet waste</p>	<p>A1.6) Temporary seal to basin waste</p>

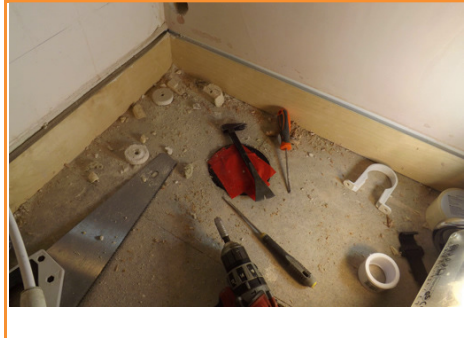
<p>A1.7) Temporary seal to waste through floor for connection from washing machine</p>	<p>A1.8) Temporary seal to incomplete waste from bath, ground floor</p>

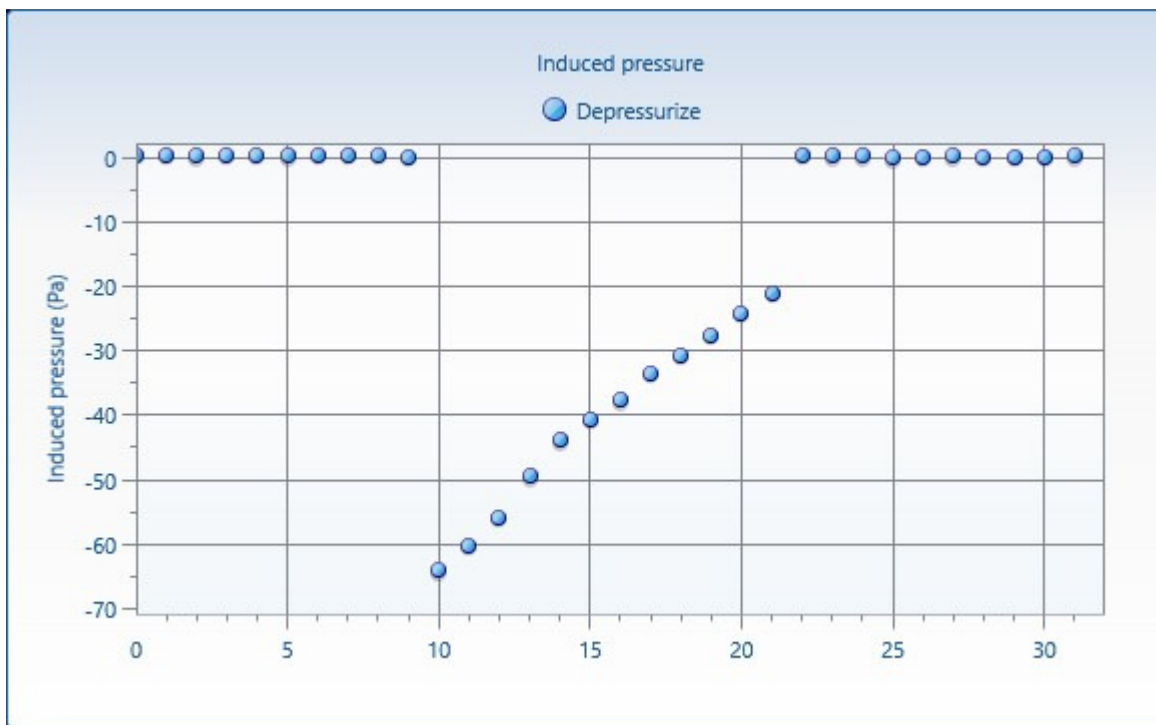
G1: Graph of imposed pressure differentials, Depressurisation, Unit 1, Wellington Lane, Bristol, BS6 5PY:

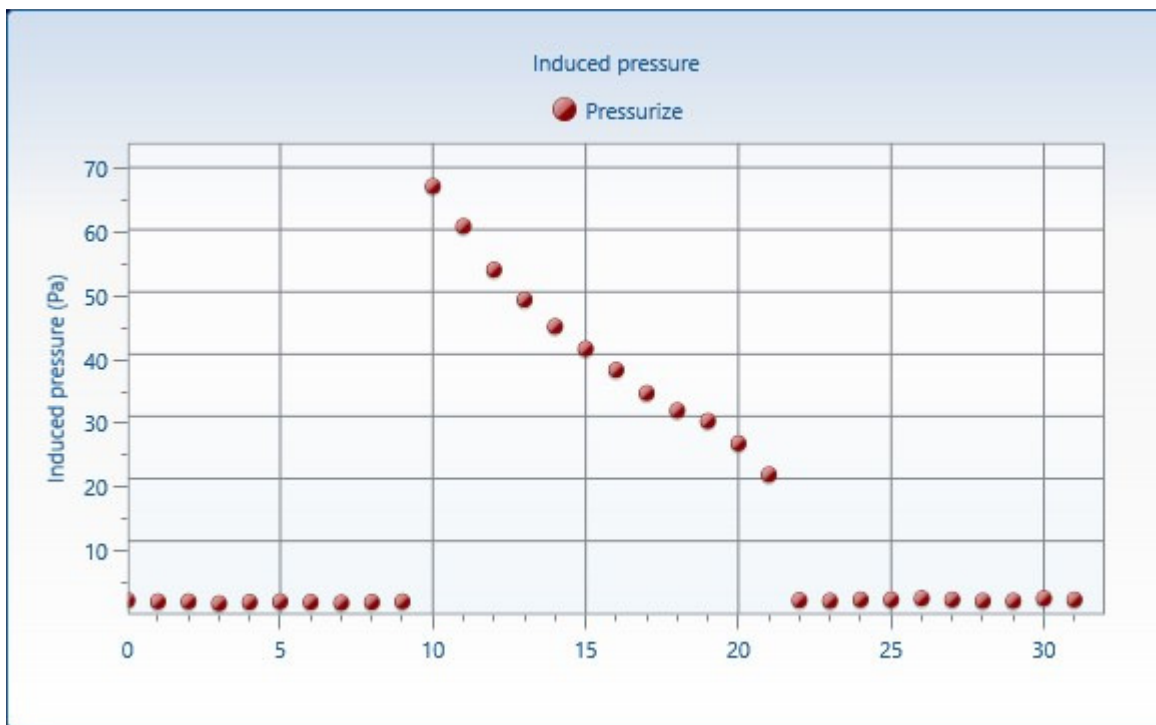
G3: Graph of imposed pressure differentials, Pressurisation, Unit 1, Wellington Lane, Bristol, BS6 5PY:
