# Passivhaus Project Documentation

## Fulford Passivhaus, York, UK

**Single-family detached dwelling in Fulford, York, North Yorkshire.**

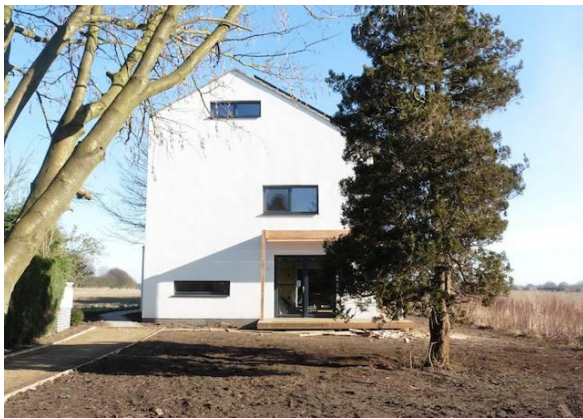
*Approach to the building from the west side.*

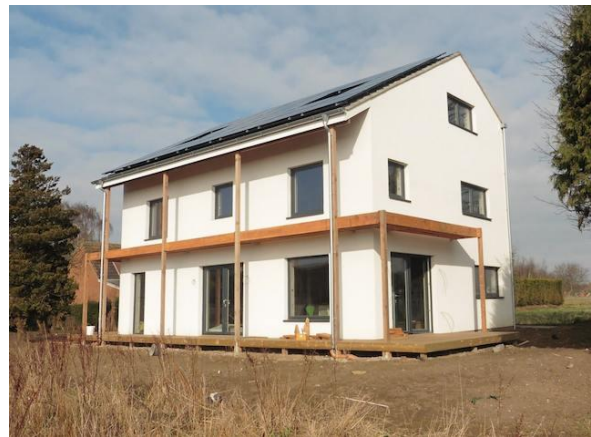
*South-east view of the house showing the shading to the south side and asymmetric roof.*

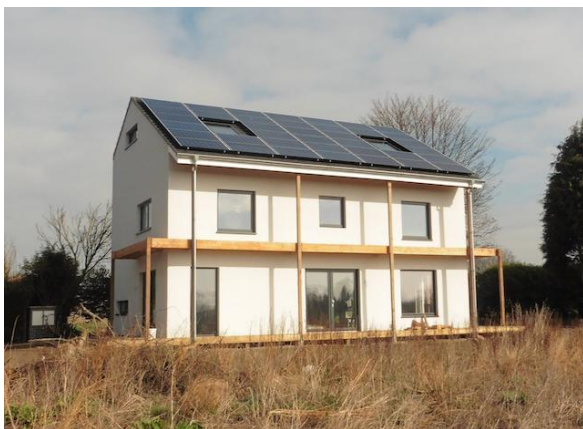
*South-west view showing the solar array.*

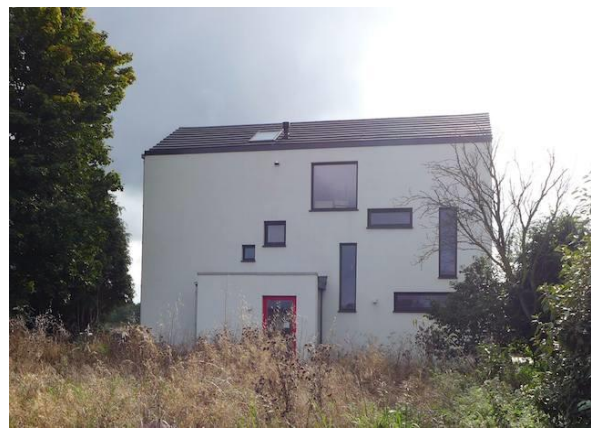
*North view of the house showing minimal glazing and projecting porch.*

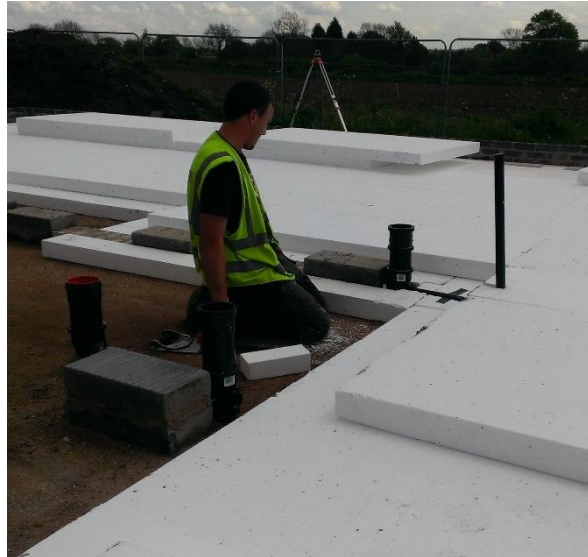
### Ground floor

The ground conditions and loadings from the timber frame structure necessitated a hybrid substructure comprising perimeter strip foundation, together with loadbearing EPS insulation reinforced with pads beneath point loads. This was complex to construct but the contractor took great care with the insulation build-up and with airtightness / waterproofing layer.

Build-up:-	100mm Concrete with polished finish DPM airtightness layer 300mm Jablite (038) Hardcore and blinding <b>U-value = 0.123 W/(m<sup>2</sup>K)</b>
------------	--

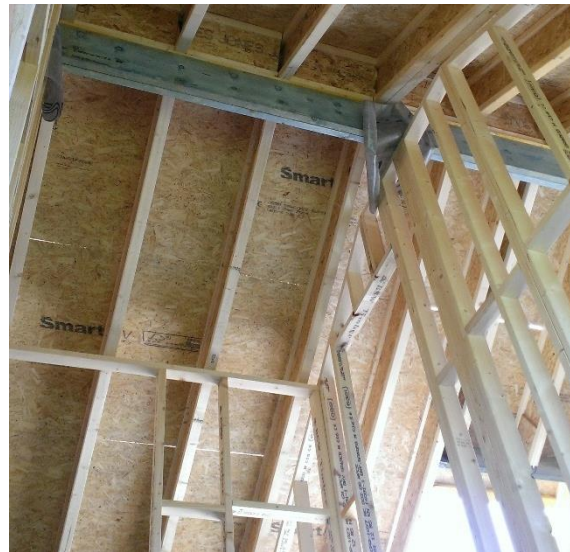
## Roof

Again cost control had an impact on the roof construction – 300mm joists were cheaper than deeper ones, so were used with mineral wool filling in combination with internal lining of PU insulation to the soffit.

Build-up:-	12.5mm Plasterboard 38mm Service void Proclima Intelloplus 100mm Celotex in two layers 100mm Superglass flanges (035) 8.3 % Timber 206mm Superglass webs (035) 2.0% Joist webs 10mm OSB <b>U-value = 0.083 W/(m2K)</b>
------------	---

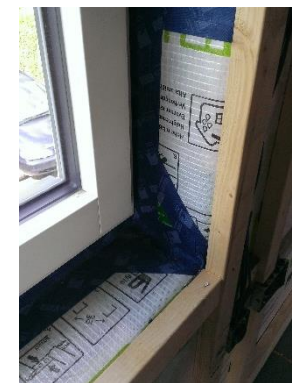
Within the external walls:- The Proclima membrane was situated inside of the PU insulation which lined the timber frame, and outside of the 38mm service void. It was stapled in place and then taped on all joints and all lines of staples.

Window and door reveals were carefully cut and taped in accordance with the manufacturer's recommendations. The client acted as "airtightness champion" and supervised the work.

The membrane was taped to the DPM where this was brought up on the inside of the timber frame at ground floor level. At first and second floor level the membrane was taken outside of the floor construction and brought back in above the floor.

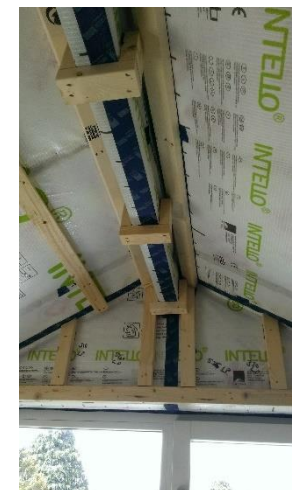
Within the roof:- The Proclima membrane was taken up the underside of the roof on the underside of the PU insulation layer, with a 38mm service void beneath. The membrane was taken underneath the ridge beam and was dressed into the rooflight openings using the same methods as for window openings.

Proprietary reveal linings were initially used as supplied by Fakro to match the rooflights, but these were ultimately discarded as being insufficiently reliable – the adhesive was not as secure as that of the Proclima tape, so in the event this was used instead.

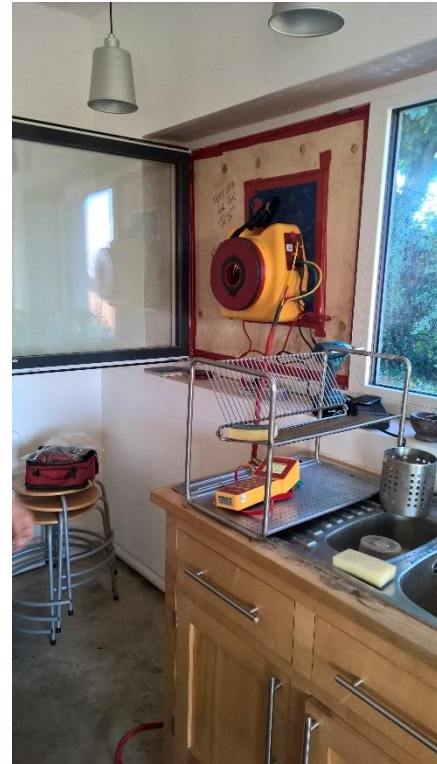
Depressurisation and pressurization test results are shown below.

Depressurize Test Results					
	Results			Results	Uncertainty
Correlation, $r^2$	0.999	95% confidence limits		Air flow at 50 Pa, $Q_{50}$ [ $m^3/h$ ]	229 +/-1.0%
Intercept, $C_{env}$ [ $m^3/h.Pa^n$ ]	11.2	10.0	12.5	Permeability at 50 Pa, $AP_{50}$ [ $m^3/h.m^2$ ]	0.60 +/-1.1%
Slope, $n$	0.77	0.74	0.80	Equivalent leakage area at 50 Pa [ $cm^2$ ]	114 +/-1.0%
				Air changes, $n_{50}$	0.44 +/-1.1%

Pressurize Test Results					
	Results			Results	Uncertainty
Correlation, $r^2$	0.999	95% confidence limits		Air flow at 50 Pa, $Q_{50}$ [ $m^3/h$ ]	193 +/-0.7%
Intercept, $C_{env}$ [ $m^3/h.Pa^n$ ]	10.3	9.5	11.0	Permeability at 50 Pa, $AP_{50}$ [ $m^3/h.m^2$ ]	0.50 +/-0.9%
Slope, $n$	0.75	0.73	0.77	Equivalent leakage area at 50 Pa [ $cm^2$ ]	96 +/-0.7%
				Air changes, $n_{50}$	0.37 +/-0.9%

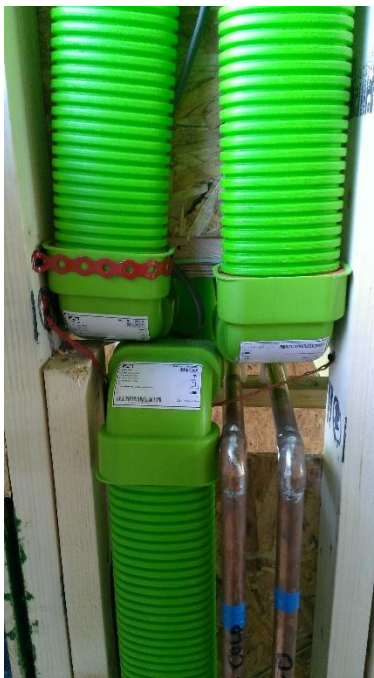
Design of the ventilation system was carried out by Adam Dadeby of The Passivhaus Store, using a Brink Renovent Excellent 300 Plus MVHR unit and Ubbink semi rigid ducting. The MVHR unit has an Effective Heat Recovery performance of 75% and Electrical Efficiency of 0.45Wh/m<sup>3</sup>.

The MVHR unit is located in a dedicated cupboard off the staircase half-landing. This is on the north side of the building and both inlet and extract ducts exit on this side – one through the external wall and one through the roof above, thus ensuring cool input air for summertime.

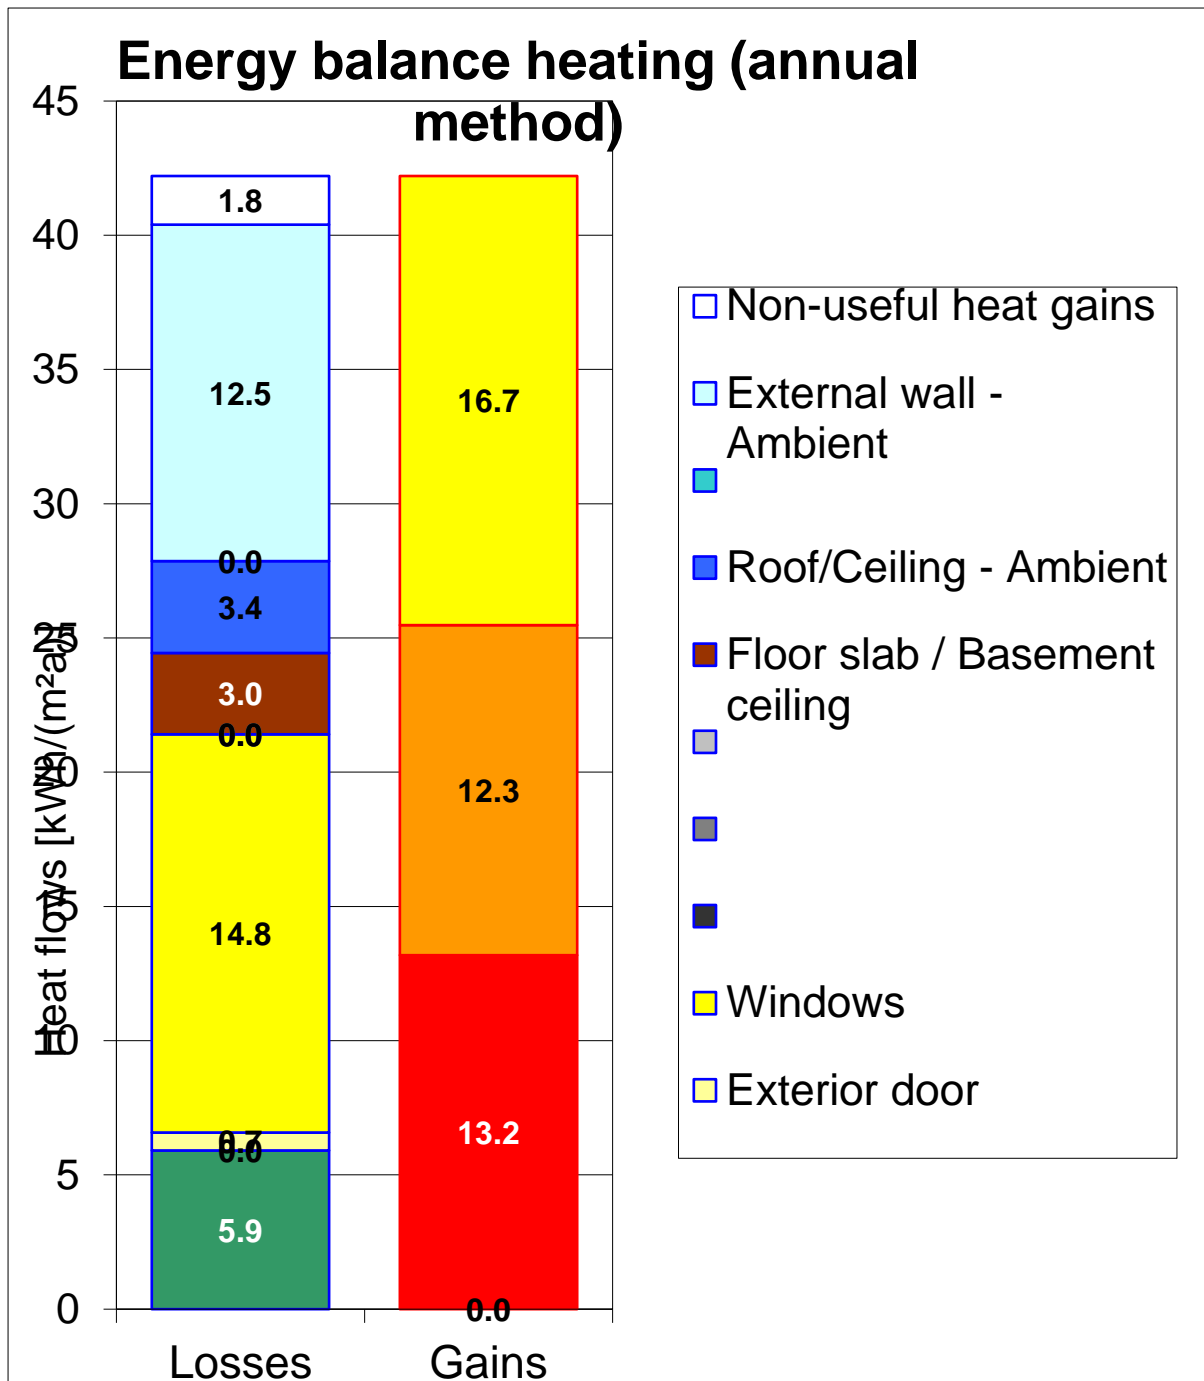
As would be expected, the main losses are from windows and external walls. The glazing area to the west and east is larger than ideal but justified in terms of wishing to make the most of views and provide good daylighting to bedrooms which would effectively be “living rooms” for teenage children. The wall construction was, as noted, a compromise required for cost-saving reasons and while it complies with Passivhaus requirements a higher level of insulation would have been ideal.
